## **REFURBISHING/REPAIR**

### **HORIZONTAL SHOT MILL**

#### **CHAMBER AND HEAD REWORKED**

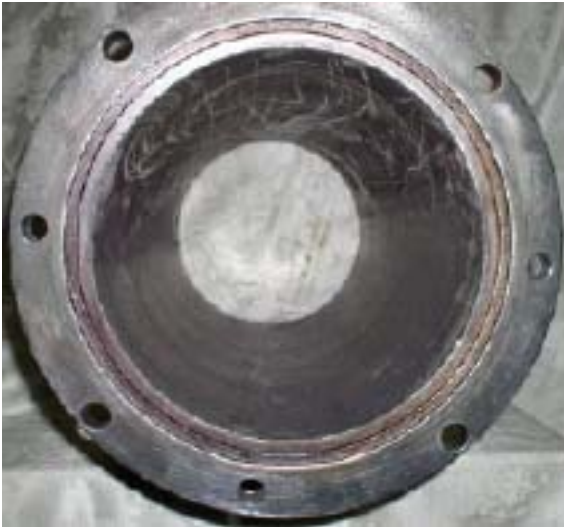
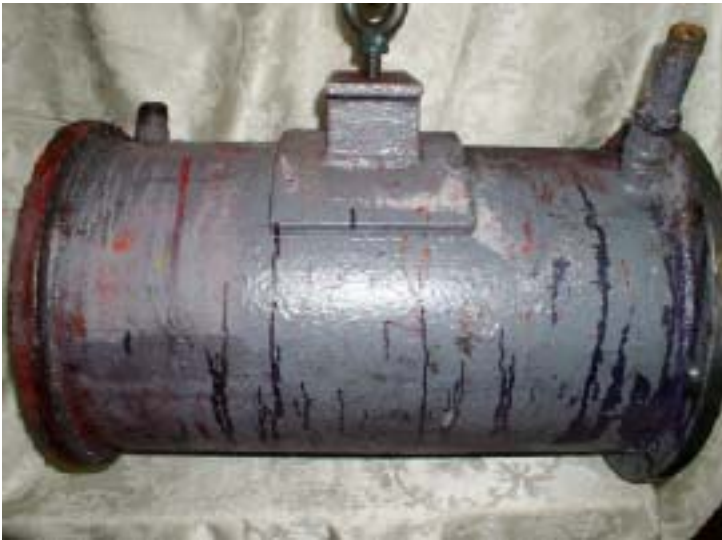
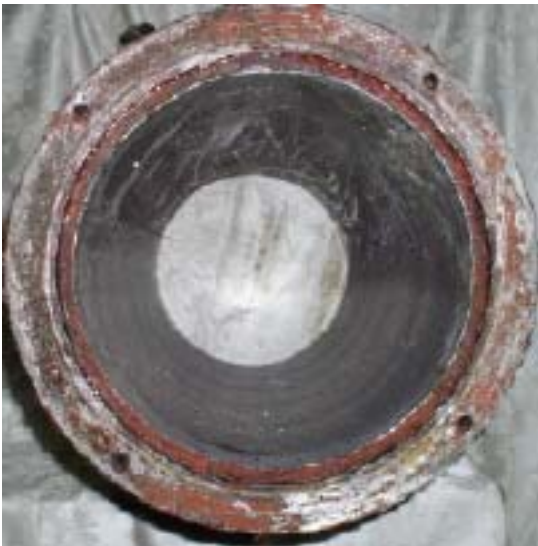
The unit was disassembled at site and trucked to shop for re-inspection and refurbishing.

The flanges had to be cleaned and re-machined to original tolerances.

The jacketed chamber had to be leak tested under pressure and re-welded where leaks appeared. Internal welds had to be ground smooth.

The head had to be pressure tested, leaks repaired with welds, machined to original tolerance, re-tested for leaks, and ready to be assembled on the chamber.

The chamber had to be mounted to the head with seal in place, realigned and torque the high strength fasteners.

The rotating mixing shaft assembly with the inspected disks in place was inserted into the chamber with seal in place and the high strength fasteners inserted with proper torque.
