REFURBISHING/REPAIR

LAB 3-ROLL MILL

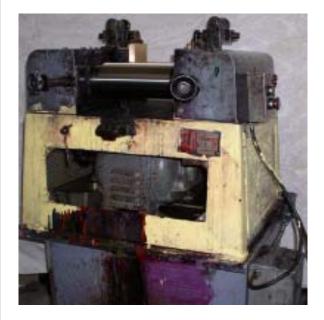
The unit was completely disassembled to expose all drive components, such as gears, pinions, bushings, bearings rolls, guides, fasteners, etc.

The stand was found to be sound and for efficiency sake was left as is. Normally would have been sand blasted, primed and painted.

All machined parts were re-machined and polished to original conditions and tolerances.

All non machined parts like bearings, bushings, seals were replaced to original specifications.

Motor drive was adjusted and realigned.

Motor controls and cabling were checked for wear and tear.
